**A PARCEL LONG LEASE LAND AND
BUILT ON DWELLING, SITUATED AT
MABON 9-F**

APPRAISAL REPORT 2025_253

The undersigned, Leo Ponson architect of profession, hereby declares to have appraised by order of APFA (Gianny Maduro), a parcel long lease land and concrete block dwelling situated at Mabon 9-F.

This appraisal is set up to determine the reconstruction value, the market value and the execution value of the premises.

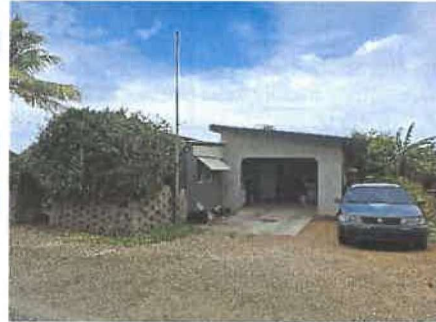
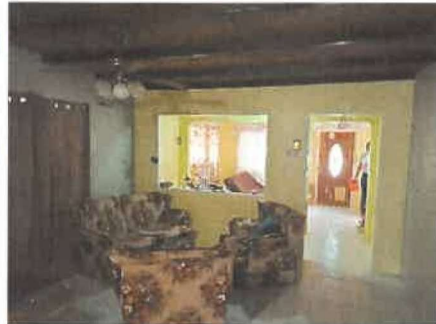
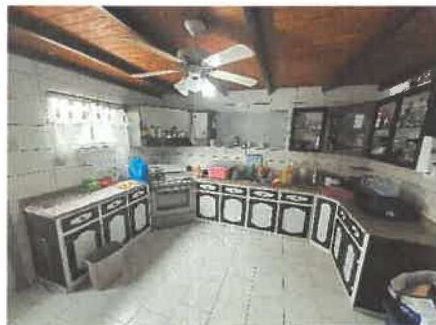
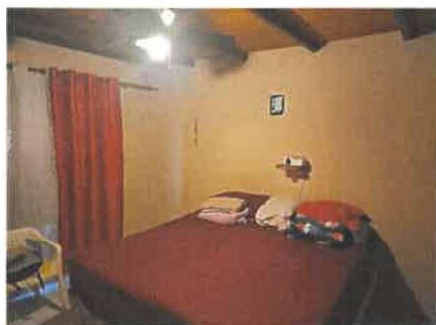
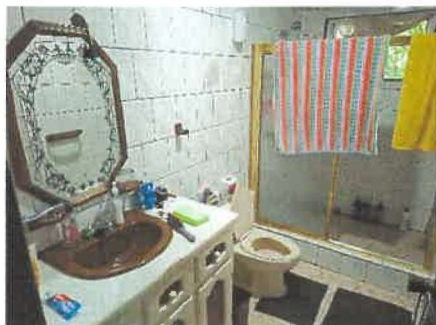
- The parcel is partially fenced off with
- Concrete block walls and concrete columns
- Not plastered and not painted
- No entrance gates

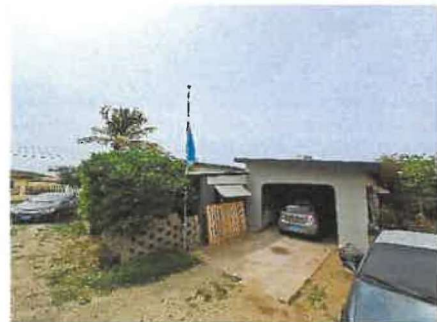
- A profound inspection of the premises was carried out, both inside and outside
- The overall condition of maintenance of the dwelling is sufficient to moderate, showing several visible defects
- The visible defects are considered regular maintenance to be conducted within 2 years

MAINTENANCE TABLE	N	G	S	M	I	P	U	Clarification
Foundation			X					
Floors				X				Multiple tiles show cracking and tenting
Walls			X					Several cracks in walls around the dwelling Several areas around the house require plaster
Roof			X					
Frames, windows and doors				X	X			Several exterior and interior doors damaged/rotten
Floor and wall tiles				X	X			Cracked and loose floor tiles
Ceiling			X					
Painting			X	X				Several areas of the exterior & interior walls and ceiling require repainting
Kitchen			X					
Bathroom fixtures			X	X				Damage faucet (vanity)
Plumbing			X					
Electrical installation			X					
Hardscape and/or landscaping			X					
Fencing			X					
<p>N: new (within 1 year after completion) G: good = as new S: sufficient = no maintenance excepted within 2 years M: moderate = maintenance excepted within 2 years (clarification) I: insufficient = maintenance / repair necessary (clarification) P: poor = replacement necessary (clarification) U: unfinished</p>
